YOUR ONESURVEY  
**HOME REPORT**

105 Forbeshill  
Forres  
IV36 1JJ

# SINGLE SURVEY

A report on the condition of the property, with categories being rated from 1 to 3.

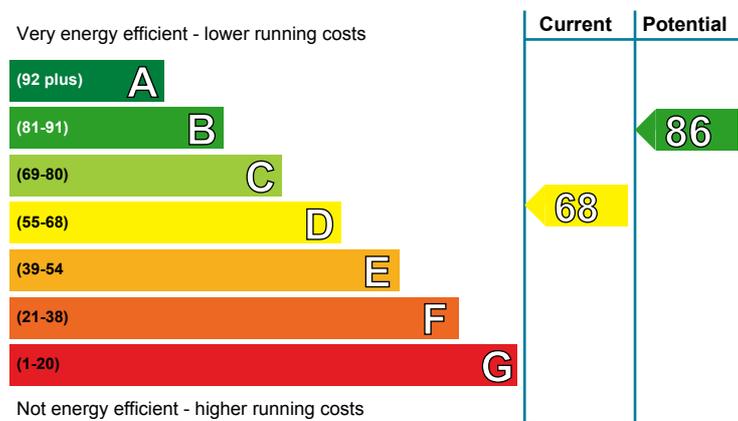
## Energy Efficiency Rating

This graph shows the current efficiency of your home, taking into account both energy efficiency and fuel costs. The higher this rating, the lower your fuel bills are likely to be.

Your current rating is **band D (68)**. The average rating for EPCs in Scotland is **band D (61)**.

The potential rating shows the effect of undertaking all of the improvement measures listed within your recommendations report.

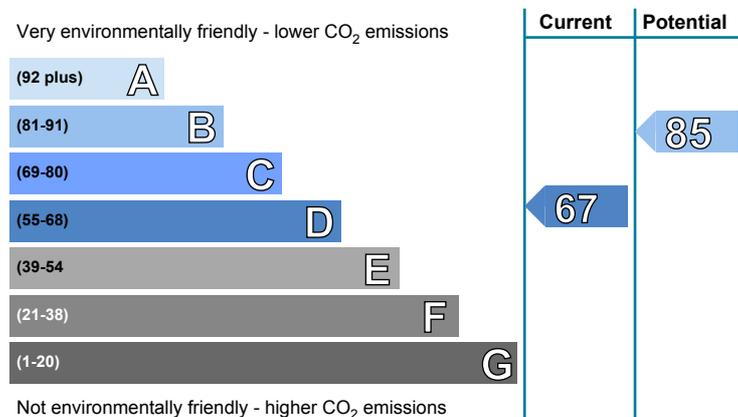
## Environmental Impact (CO<sub>2</sub>) Rating

This graph shows the effect of your home on the environment in terms of carbon dioxide (CO<sub>2</sub>) emissions. The higher the rating, the less impact it has on the environment.
